Durability and Safety Concerns for UK Canopies Built Pre-1989

By Martin Steggles, Managing Director, Global-MSI

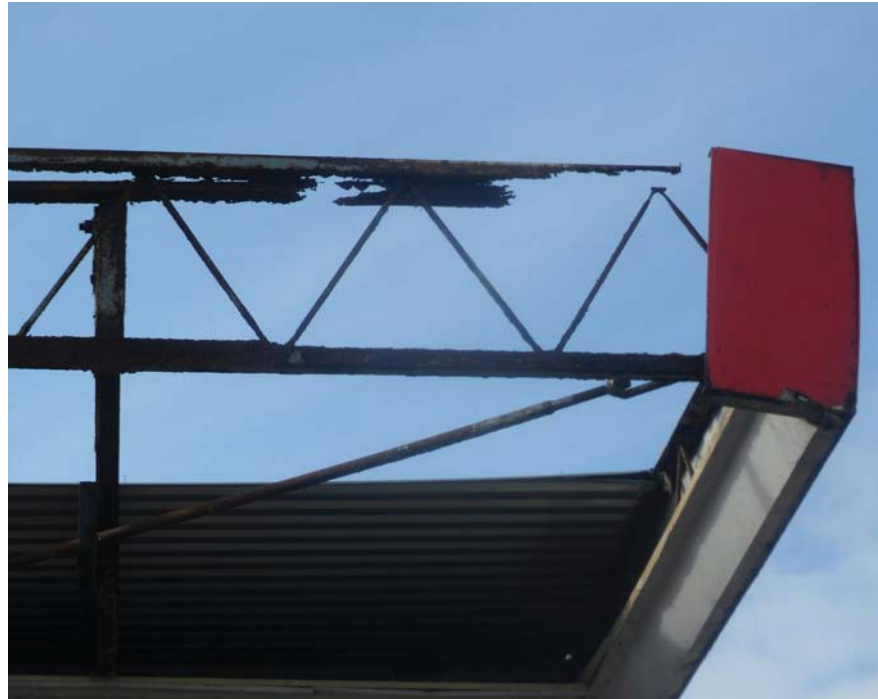
This photograph was taken following the winter storms of 2013/14. During windy conditions, image fascias and sheeting became detached from the canopy. The extensive corrosion of the canopy steelwork was a major contributing factor."

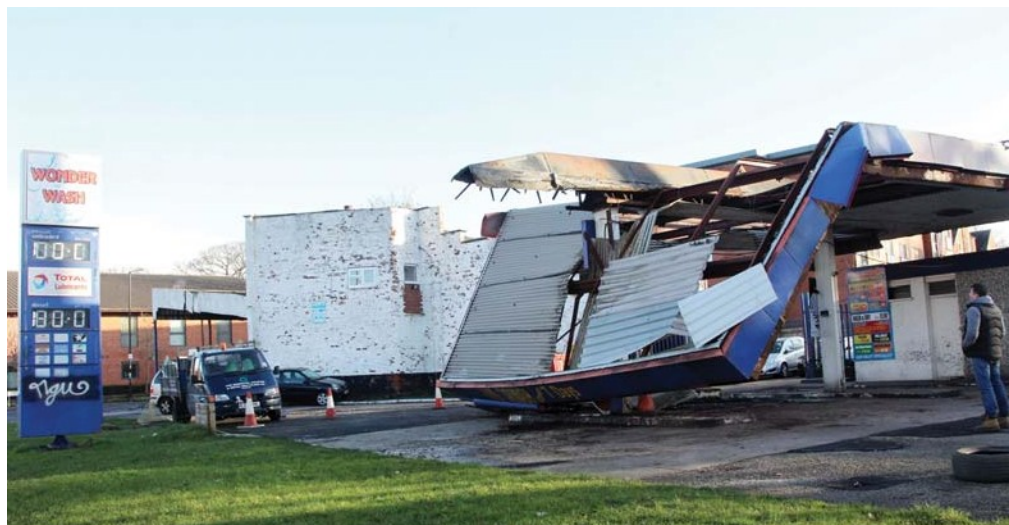
The above photograph shows a former filling station canopy at a car wash premises in Greater Manchester following collapse in February 2014 (the 'A-frame' is still visible protruding above the collapsed structure). The external appearance of the canopy would have given little indication of the endemic deterioration the main canopy deck steel members had suffered. It is cases such as this that strengthen Global-MSI's belief that in the near future an ageing UK filling station canopy will suffer a sudden structural collapse.

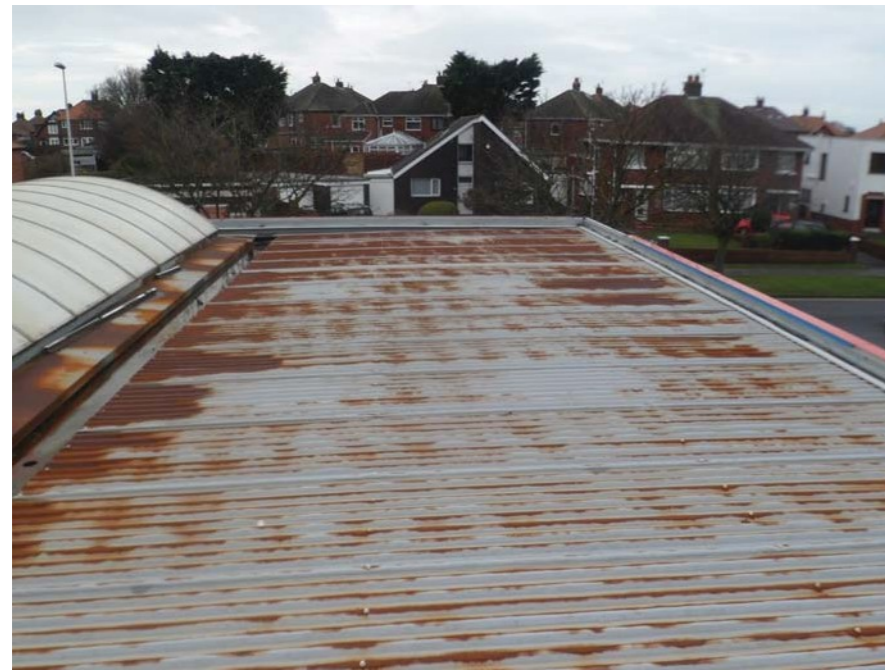
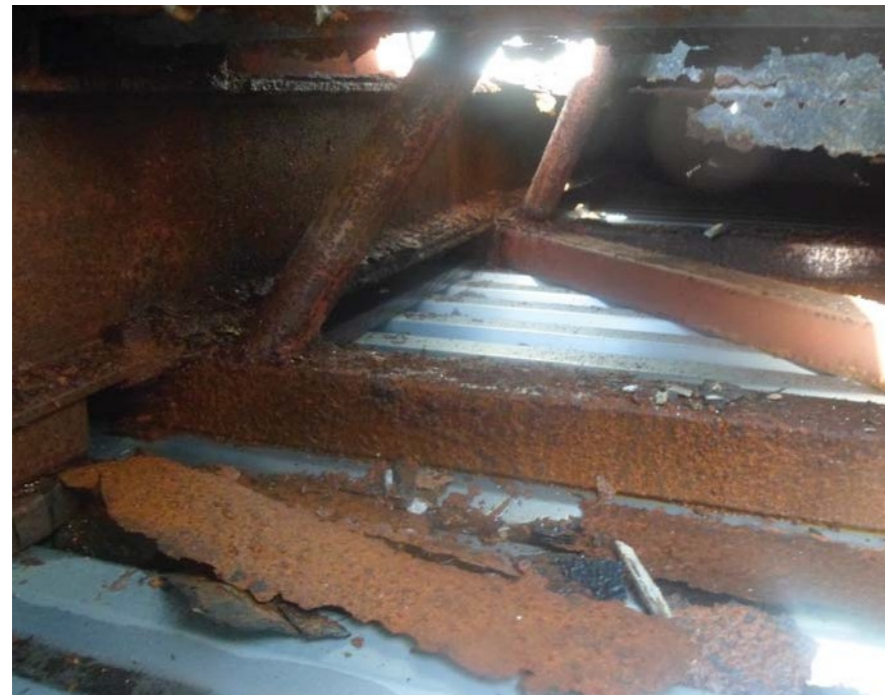
The above photographs show the extent of accelerated corrosion due to air pollution on a series of profiled steel roof sheets. The resulting damage has caused the roof deck to lose watertightness exposing the supporting steelwork below to acidic rainfall and increased moisture

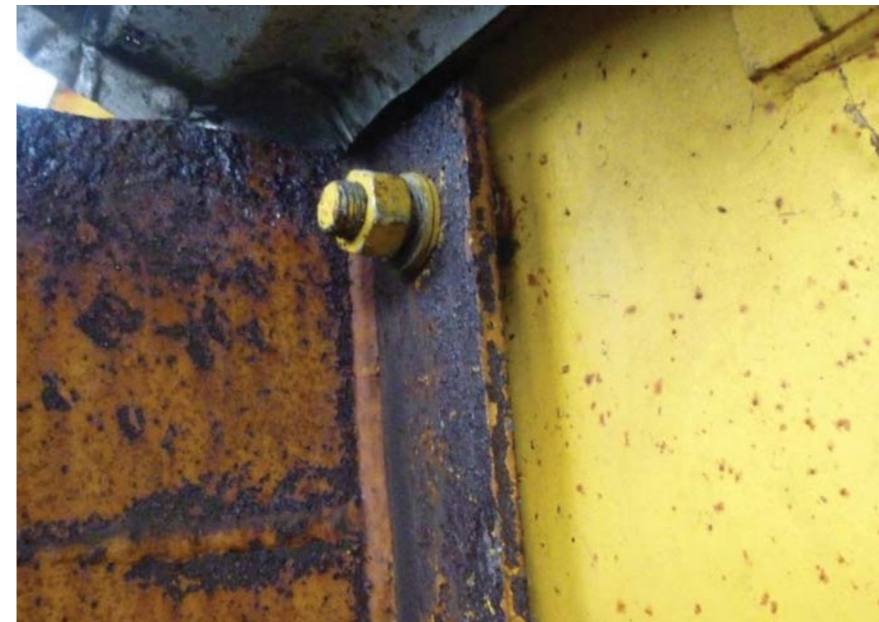
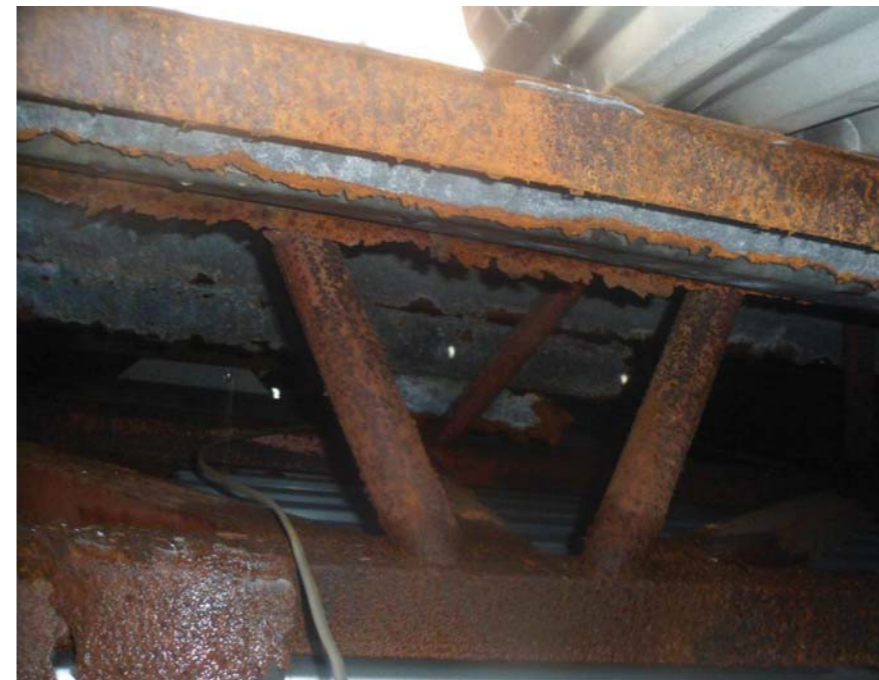
These two photographs were taken during recent surveys of filling station canopies that have exceeded their intended 25 year design life and the indicated damage typifies that of ageing canopies that have not been regularly maintained. The first photograph is from the same canopy supplier as the partially collapsed structure featured above. The second photograph shows a loose bolt forming the connection of two primary structural beams – a common occurrence increasingly being witnessed by Global-MSI's surveyors.

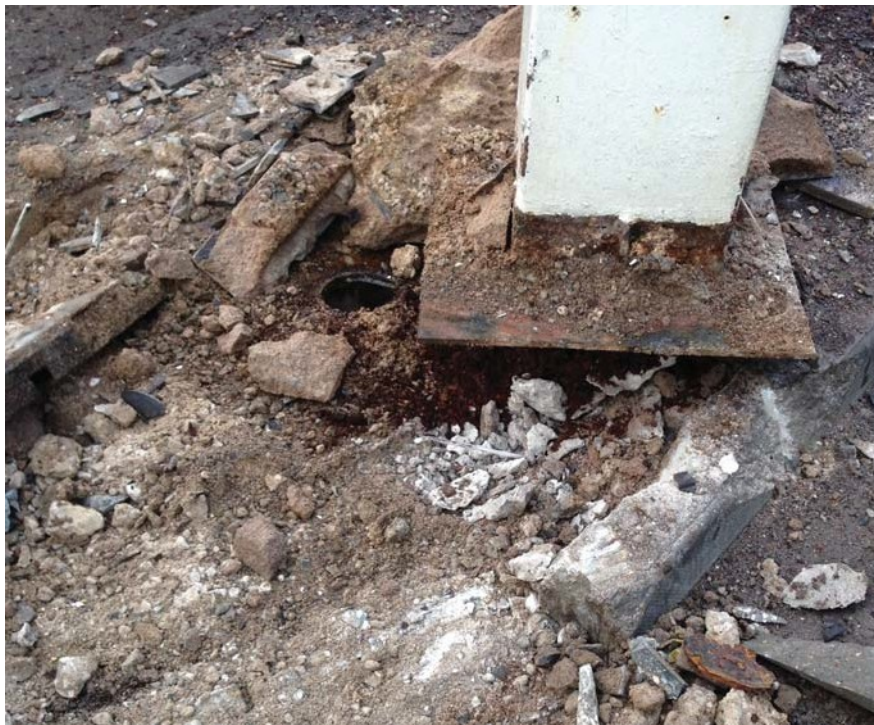
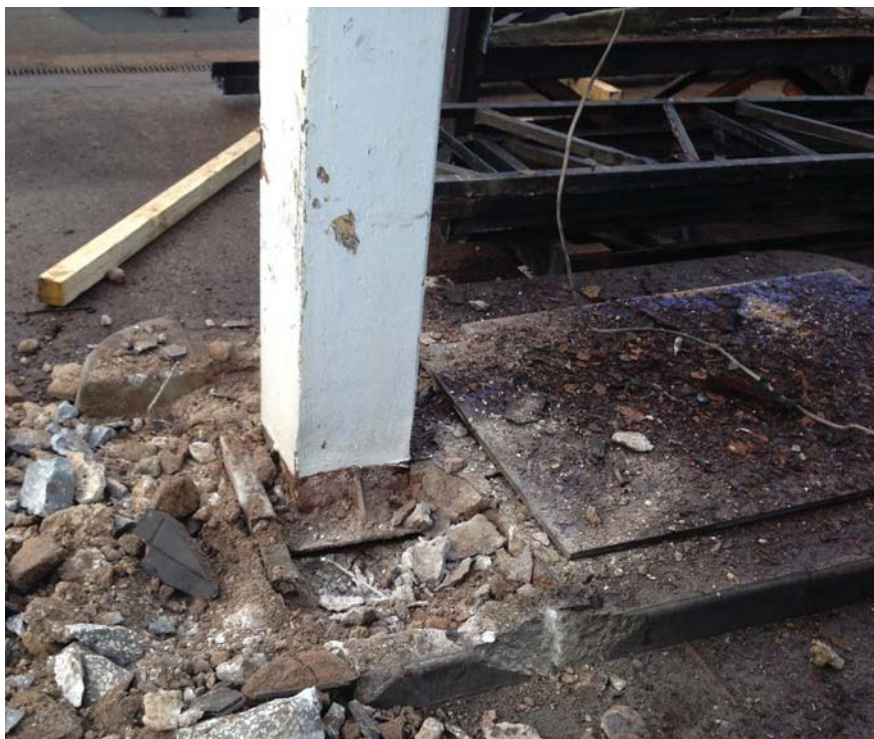
These two photographs were taken during the dismantling of a filling station canopy in February 2014. Global-MSI's concerns are not just limited to poor condition and lack of maintenance of canopy roof structures. The canopy columns above have no holding-down bolts securing them to foundations. They were simply placed onto the forecourt slab and covered by the pump island.
